Bellaterra : May 6, 2016  
Report number : **16/12140-806**  
Petitioner reference : **STYLAM INDUSTRIES LIMITED**  
SCO 14, Sector 7C, MADHYA MARG.  
CHANDIGARH, INDIA  
PIN: 160019

## TEST REPORT

| <b>LAMINATE FLOOR</b> | |

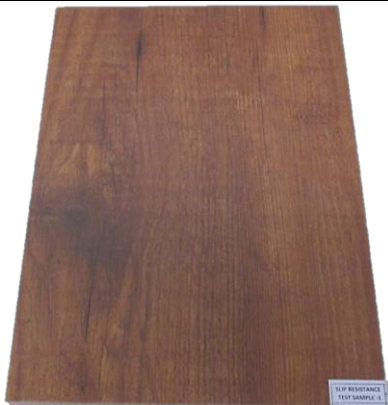
As of April 7, 2016, has been received in LGAI-Applus a sample pavement with the following references by the Petitioner:

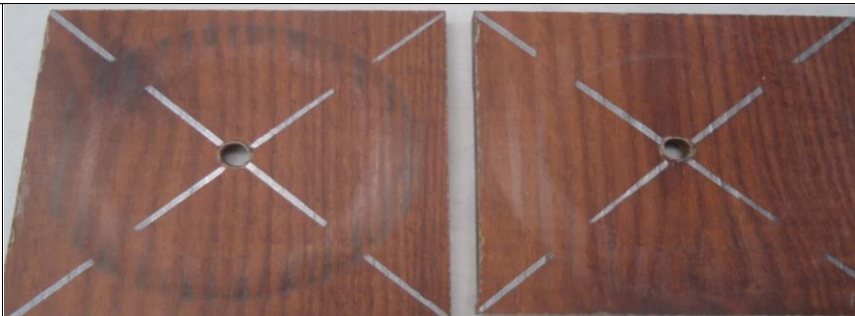
| <b>Classification AC3<br/>( 2000 cycles )</b> | |

| <b>Value obtained:</b> | <b>Taber abrasion resistance (IP) :<br/>Classe AC3 ( 2650 cycles )</b> |

| According to the standard 13329: 2007+ A1: 2009, the level of use: | | | | | | |
|---|---|---|---|---|---|---|
| The initial wear point (IP) is the point which clearly manifest the disappearance of the printed design manifesting underlying face in 3 quadrants. The initial wear point is reached when there are areas in two quadrants of wear of at least 0,6mm2 each and begins to manifest wear and tear of area 0,6mm2 in the third quadrant. In the case of printed designs, sublayer is the background on which is printed the design. If plain colors is the first layer of different color. | | | | | | |

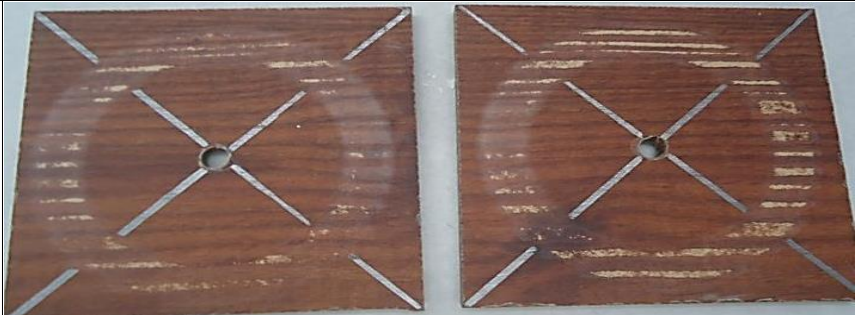
| <b>Classification AC4<br/>( 4000 cycles )</b> | |
